# Wayfinding at the East Campus of Cayuga Medical Center in Ithaca, NY

Joowon Ahn

**East Campus Introduction**

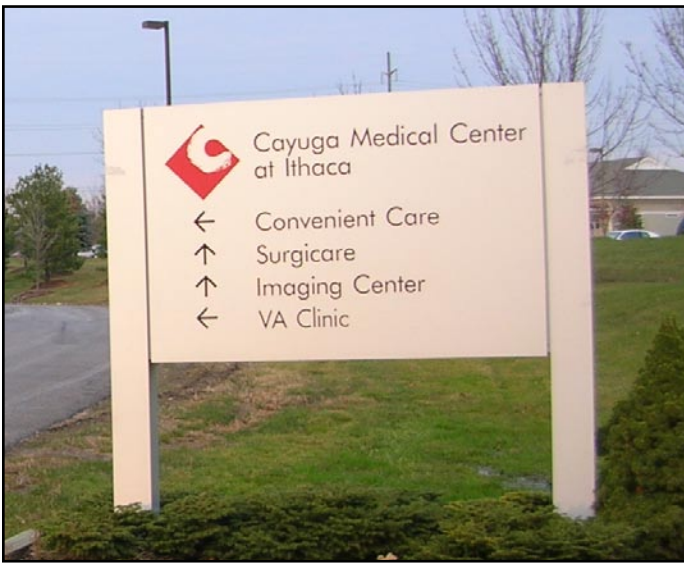
**Figure 1.2. Main exterior signage.**

The inadequate design of the sign further reduces its effectiveness. Several problems include poor legibility from low contrast and inappropriate type face, and destinations that are not organized by directions. Also, the sign is invisible at night, even though Convenient Care operates until 10 p.m., with no interior/exterior illumination or reflective lettering.

Another crucial function the sign lacks is guidance of visitors to appropriate departments, especially those who are making walk-in visits for the first-time. Visitors may not recognize the services they provide just by the names of the departments, such as Convenient Care. A good example of immediately recognized terms for similar types of services is “urgent care.” Confusion and stress from unnecessary wandering can be reduced if the visitor can identify the appropriate destination from signage.

| EXTERIOR WAYFINDING | | |
|---|---|---|
| Home ►<br>Parking | Car | <ul style="list-style-type: none"> <li>◦ The exterior sign at the driveway should be relocated closer to the actual decision point; it should be redesigned for comprehensibility and legibility; it should also be visible in the dark with illumination or self-reflective feature.</li> <li>◦ The directory should list the different services provided according to departments to reduce confusion.</li> <li>◦ Color coding should be implemented other than the main signage to effectively guide people to the correct parking lot.</li> </ul> |

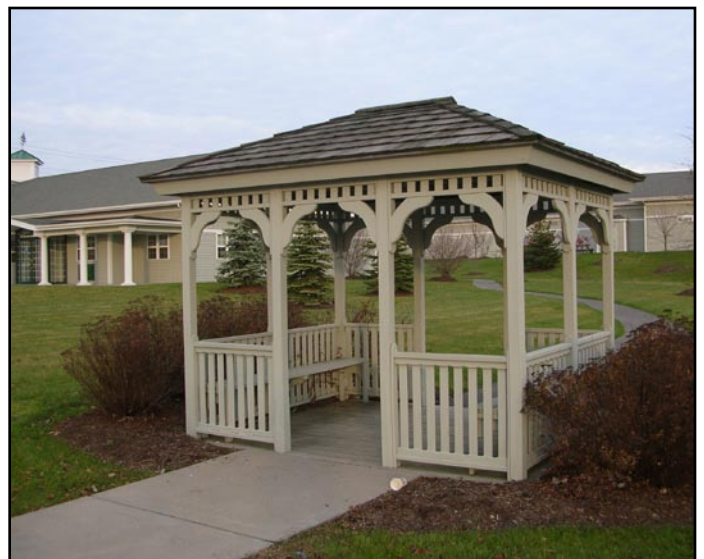
The bus stop completely lacks functionality other than the seating it provides. As shown in Figure 1.3, it cannot be identified as a bus stop. No signage is to be found, including the TCAT bus logo, schedule, and other necessary information for

**Figure 1.3. Bus stop with no identification.**

the passenger. The bus stop also lacks any lighting source for evening visitors. In addition, the lack of immediate adjacency between the bus stop and the East Campus only confuses the passenger further. If the facility were immediately visible, the building itself would verify the correct stop without any additional signage.

| EXTERIOR WAYFINDING | | |
|---|---|---|
| | Bus | <ul style="list-style-type: none"> <li>◦ The bus stop should be clearly marked with a landmark or a sign to inform visitors to get off; it should also provide a clear schedule.</li> </ul> |

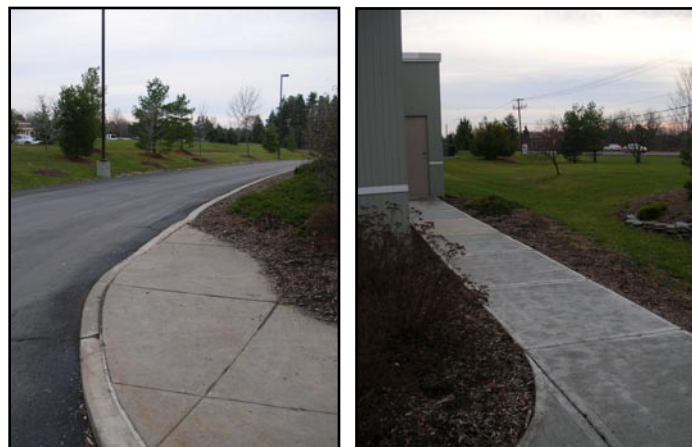
Once the visitor is in the right parking lot, it is not difficult to find the main entry to the department. However, visitors in the wrong parking lot are greatly challenged to find their destinations. Once past the main signage near the entrance, there are no additional signs that guide the visitor to different departments. Each department is identified with a large exterior sign, but the signs are only visible from the correct parking lot. For

**Figure 1.4. No sidewalks to travel around the complex.**

instance, visitors who make the wrong turn into the Convenient Care parking lot have no guide to Surgicare or Imaging Center, which are on the opposite side of the complex. There are also no walkways that connect the two sides (Figure 1.4). Not only does this discourage wayfinding, but it is also extremely hazardous to expose pedestrians to the car traffic, in case some visitors walk around the complex.

| EXTERIOR WAYFINDING | | |
|---|---|---|
| Parking ►<br>Main Entry<br>(Specific Departments) | Car | <ul style="list-style-type: none"> <li>◦ Visitors should have safe sidewalk access to all departments from both parking lots, to protect any pedestrians from the car traffic.</li> <li>◦ Employ a well-designed signage and color coding in both parking lots for clear directions to various departments.</li> </ul> |

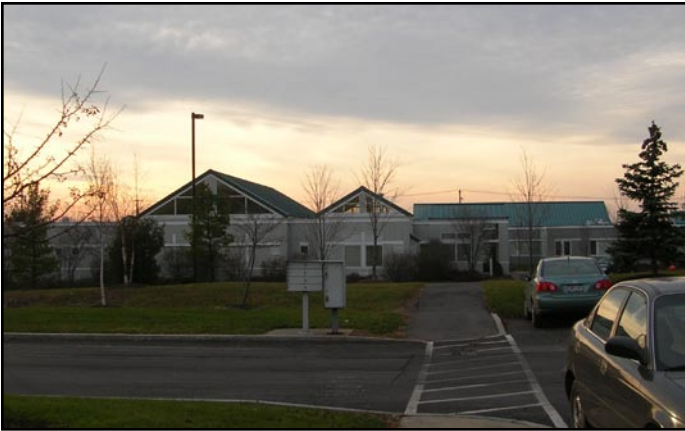
There is not a single signage near the bus stop to direct visitors to the East Campus of CMC. The visitors may not even recognize the facility with no visible landmarks nor noticeable architectural differences from the surrounding buildings (Figure 1.5).

**Figure 1.5. The facility has no signs or other forms of identification. There are still no signs when further proceeded.**

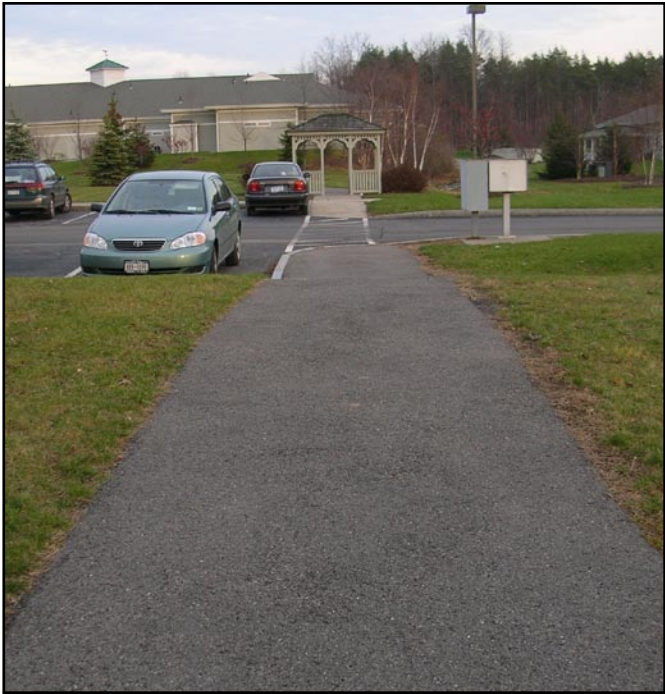
In order to get to the facility, visitors have to walk on the unlevelled paved path with no handrails (Figure 1.6). This path is especially dangerous during winter with heavy snow, and visitors in

wheelchairs have no access to such steep, uneven ground surface. They also need to cross two roads with no clear crosswalks, when it is strongly asserted to provide immediate access to sidewalks for visitors in wheelchairs (Carpman & Grant, 1993).

**Figure 1.6. Unleveled paved path with no handrails.**

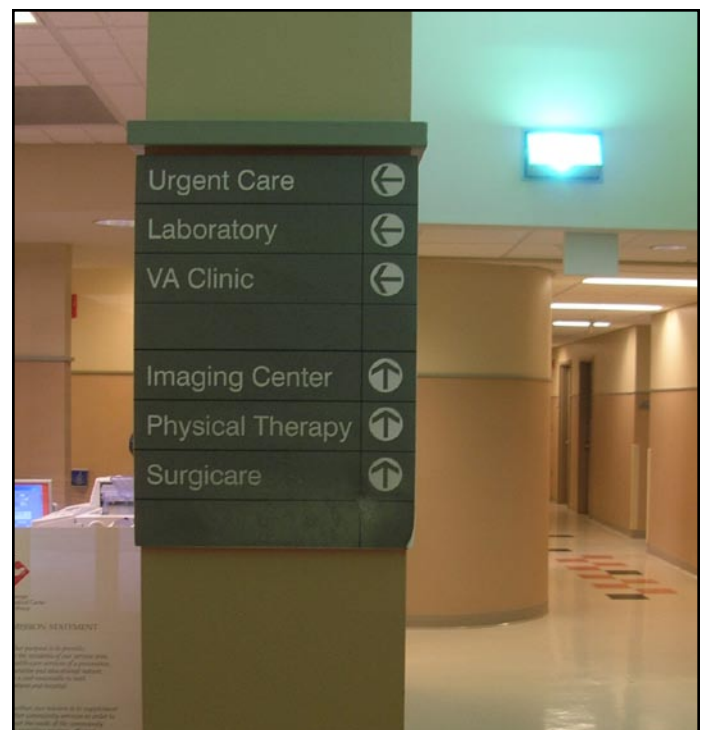
First of all, the main wayfinding signage (Figure 1.6) has many design problems that greatly reduce its legibility: The contrast of the background color and the letters is too subtle; letters are too small (0.85 inches tall) for the distance viewing from any further than 3 feet (Sanders & McCormick, 1992); and no brails for visitors with visual impairments (Carpman & Grant, 1993). The arrows for the main signage are minimal and insufficient as well. Without sophisticated correlation between the navigator's standing point and the destination,

**Figure 1.6. Main signage system at the East Campus. It lacks contrast, is too small, and has no brails.**

arrows combined with text will create more confusion (Hardin, 1995). Also, redundancy of arrows in one signage can be overwhelming (Evans, 2004).

The facility needs a uniform signage system of easily legible signs that are located adequately. The text for each signage should be high in contrast with the background hue, its dimensions should be appropriate for the viewing distance, and it should also implement brails or any other systems for those with visual impairments. Pairs of hues that have the highest contrast level are dark gray and white or black and white (Carpman & Grant, 1993). Most appropriate dimensions of letters for a general wayfinding purpose are (Sanders & McCormick):

Stroke width to Letter Height = 1:6  
Letter Width to Letter Height = 3:5

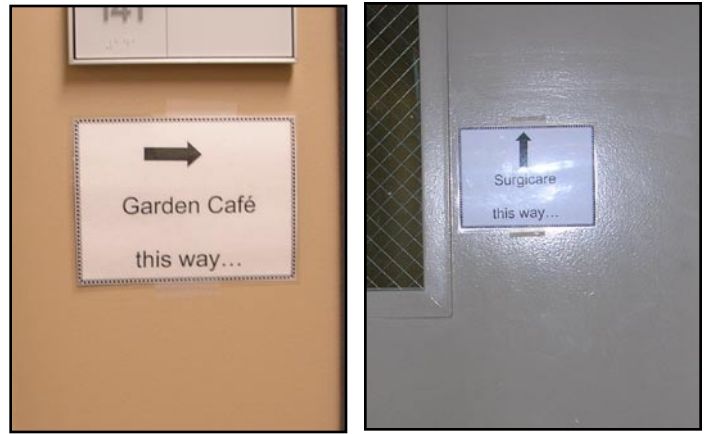
In addition to design flaws for individual signs, the overall signage system lacks consistency. As certain spaces were changed and created, the signage system was modified or added on as well, with no uniform design scheme. Some added-on signage was not even aligned to the original, creating a major spatial disruption (Figure 1.7A, B, C, & D).

Figure 1.7C. Added on signage.

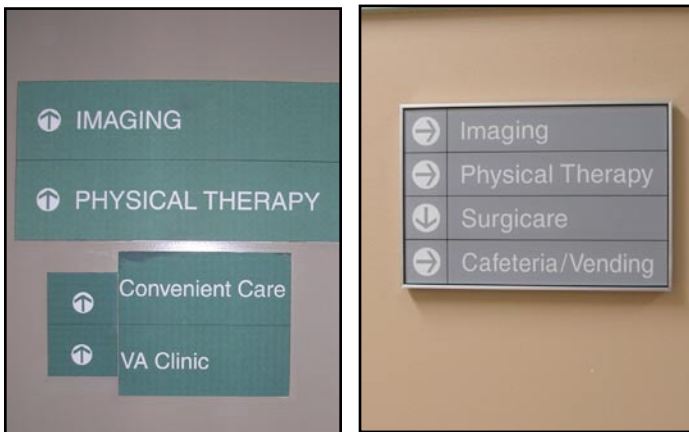
Figure 1.7A. Inconsistency in the main signage system.

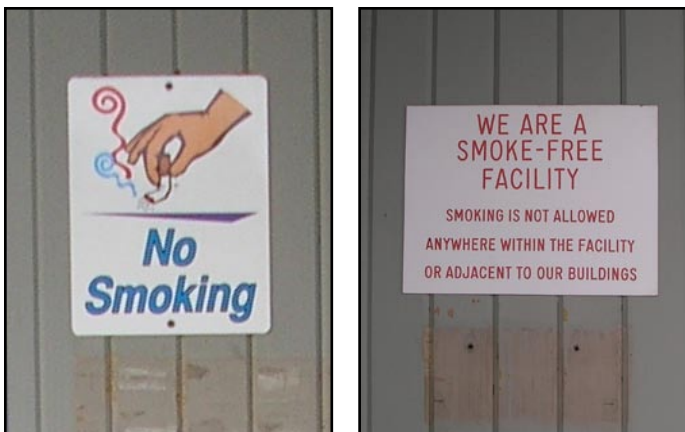
Figure 1.7B. Three different types of smoke free signage in one place.
